# UNDERSTANDING EV GEAR REDUCER OIL CONDITION

## 2017-2021 Hyundai Ioniq and 2018–2023 Kona, 2018–2022 Kia Niro EVs

Rev 2.3, 6 Feb 2025

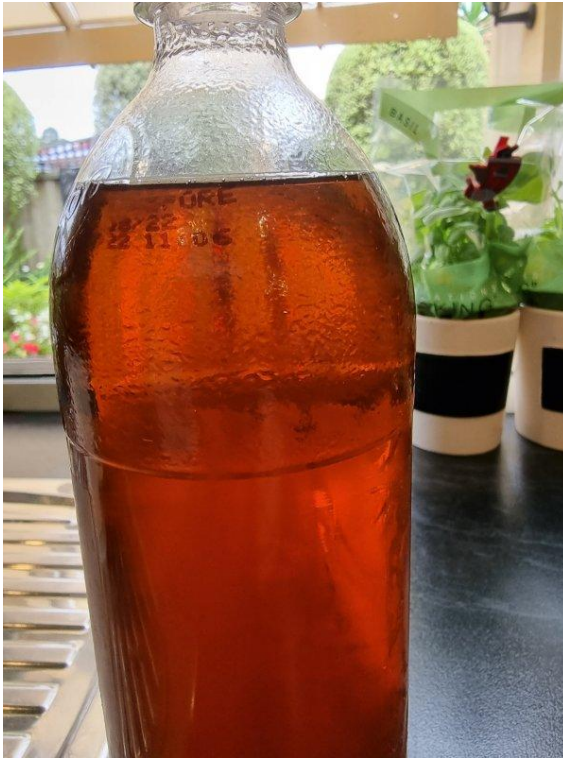
Photo of new oil: OzKona

- i) The gear reducer unit (GRU) lubrication requirements as called out in the owner’s manual are for a 70W GL-4. The Product Data Sheet for the OEM full-synthetic Hyundai/Kia 70W DCT oil describes it as “clear brown” in colour. 1.05 litre is installed.

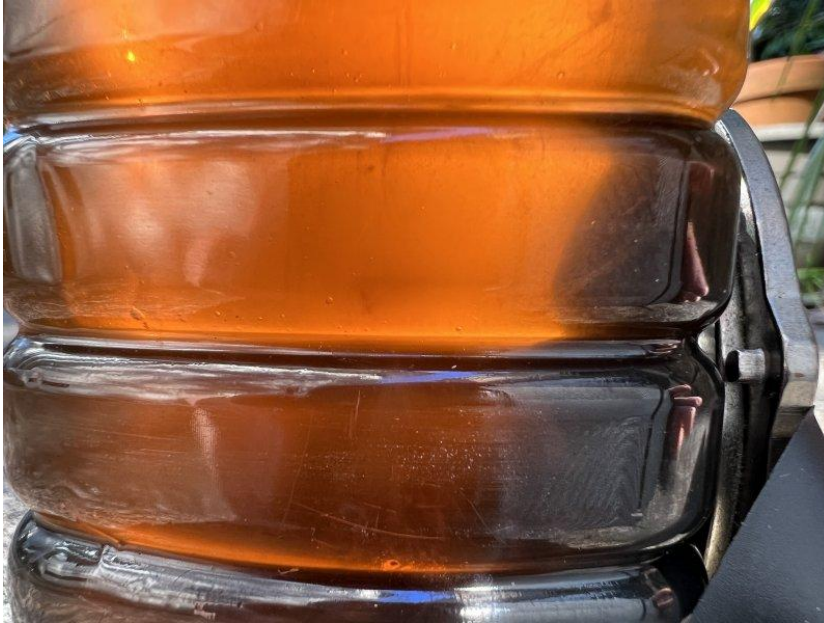
Photo of slightly used oil: KonaAU

- i) Fresh steel wear particles shed off gears and entering circulation in the oil will have at least a partial attraction to a magnet and should stick to one if passing close by. The oil in this photo was removed from a new Kona with only 142 km, perhaps 4 hours of operation. Note the large dark cluster of particles clustered near the magnet placed against the plastic bottle at the right.

Ignoring that question for the moment, it's clear that an early oil change at about 500 km would remove those particles, preventing them from causing damage as they circulate.

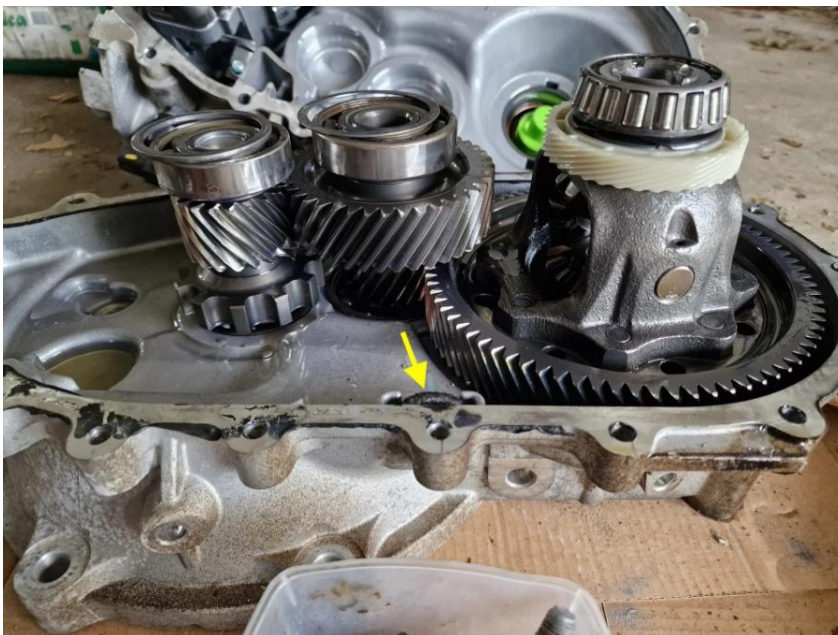
Photo: Ioniqforum.com

- ii) You might wonder why these particles came out in the drained oil rather than remained inside attached to the factory's round internal magnet, located on the floor of the GRU at the yellow arrow in the photo below? This magnet is not intended to be cleaned during the life of the EV.

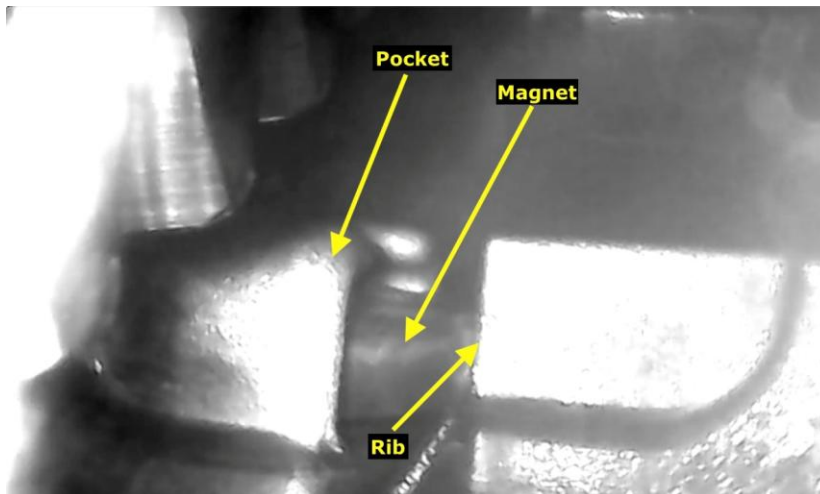
Photo of internal factory magnet using an inspection camera: KiwiME

- iii) Common design practice would have the magnet placed inside the GRU where fresh particles would be most likely to find it quickly and be removed from circulation. Perhaps for ease of installation the magnet has been designed to sit loosely in a pocket on the GRU floor and kept from escaping by a rib feature opposite. As such it can move approx 4mm out of the pocket until it hits the rib. It can also move about 2mm side to side and about 3mm upwards.

Note that the magnet in my Kona at 27,000 km (see photo above) appears free of the particles it was designed to catch. Now why would that be? This evidence is essentially the smoking gun.

For whatever reasons particles are either not being caught, or are caught then worn down and eventually rubbed off during movement of the magnet. Simple tests demonstrated that the magnet does have good, if not excellent magnetic attraction.

A simple solution for the manufacturer may have been to simply delete the internal magnet in production and install a conventional magnetic drain plug. A suitable preventative action for dealers would have been to carry out at least one oil change shortly after new-vehicle delivery.

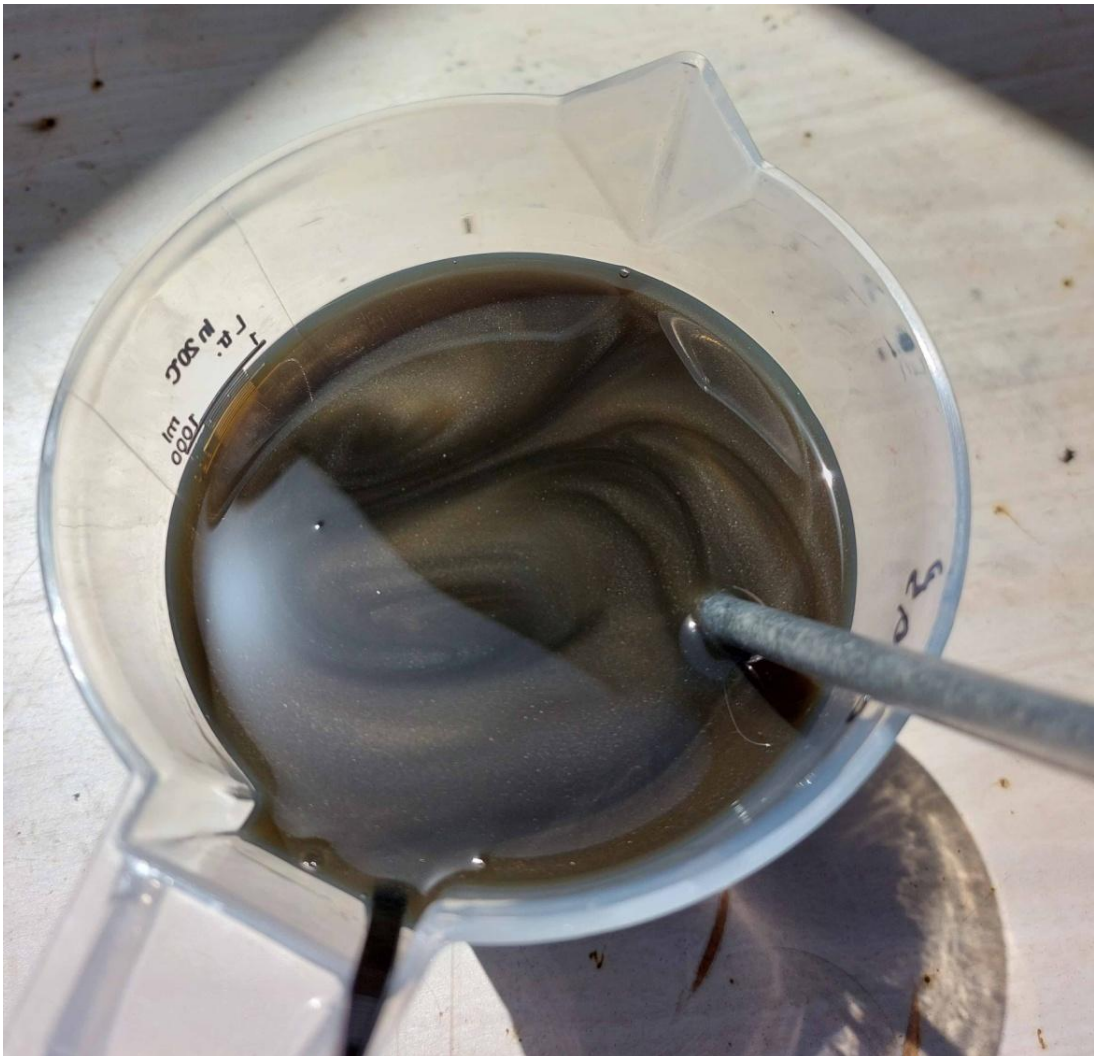
2,000 km, photo: 08crd

- i) Any particles present in the oil circulation will be repeatedly ingested and crushed by meshing gear teeth and rolling-element bearings. As a result of that mechanical working particles are not only reduced in size, but turn black in colour due to the localised heating and lose any magnetic attraction remaining.

- ii) The gears themselves incur minimal damage, but this process is detrimental to precision rolling-element bearings and will reduce their overall lifespan. The raceways develop a matte wear pattern as particles caught in the raceways disrupt the rolling motion and result in micro impacts to the surfaces.

- iii) The photos below, taken at 2,000 and 4,000 km respectively, are typical of the oil's reported condition by the *vast majority* of owners who have posted photos, a mixture of visible silver particles and grey or blackened oil. This level of contamination would *not* provide the level of lubrication cleanliness expected by Hyundai's engineers.

- iv) If the critical earlier oil change was missed at 500 km, changing the oil as soon as possible during this period can still reduce further damage. If the oil was found contaminated at 500 km another change at 1,500 km would be beneficial.

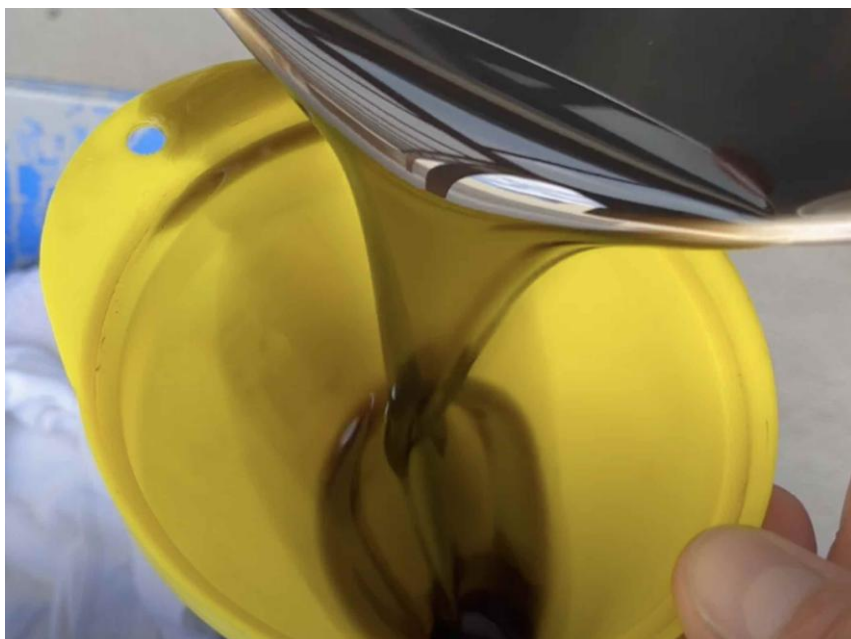
19,200 km, photo: KiwiME

- i) Eventually new wear particle generation drops to a low level and the process of particle reduction completes, leaving them invisible to the eye. This also leaves the oil in what *appears* to be a relatively-clean state.

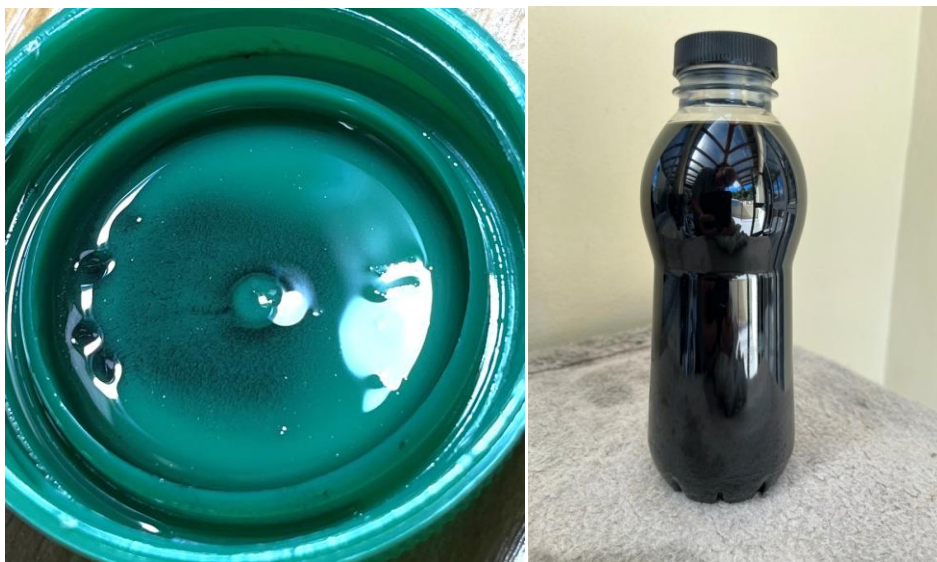
photo: KiwiME

- ii) When placed in a bottle however it looks completely opaque. A used-oil analysis would reveal the moderate iron content and a few tiny black particles might be teased out with a magnet. The effect of the oil on the GRU ongoing may not be any worse than having clean oil and as such carrying out an oil change at this stage is unlikely to have much benefit as the bearing damage has already occurred.
