# UNDERSTANDING EV GEAR REDUCER OIL CONDITION

## 2017-2021 Hyundai Ioniq and 2018–2023 Kona, 2018–2022 Kia Niro EVs

Rev 2.3, 6 Feb 2025

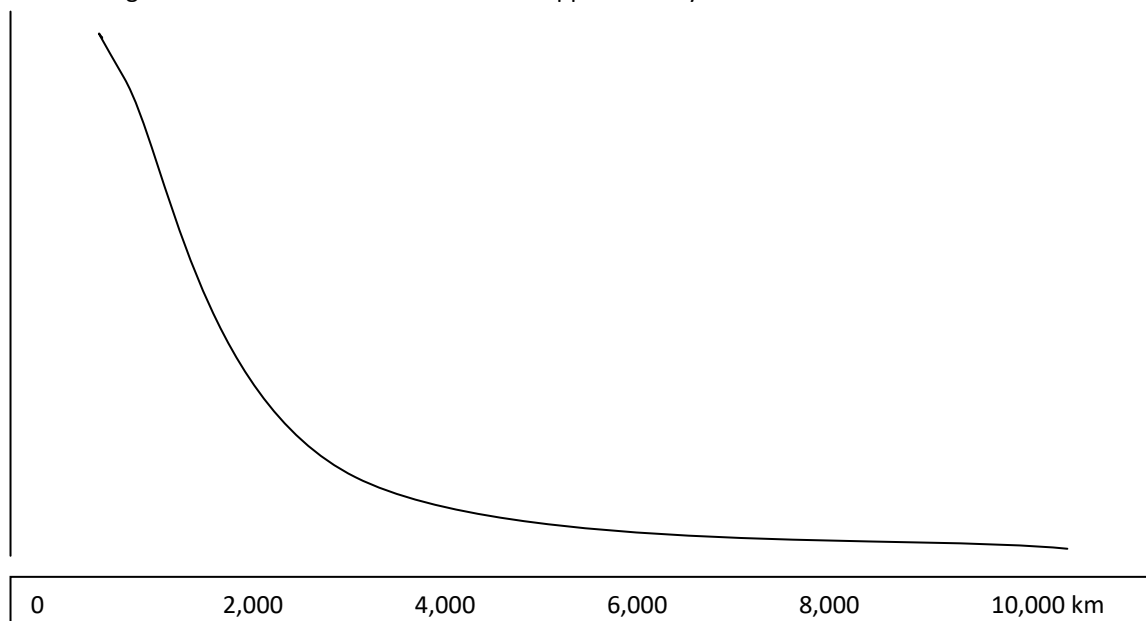
- ii) In general for gears, the rate of steel particle generation due to the initial break-in wear of machined gear tooth surfaces will follow a curve approximately like this:

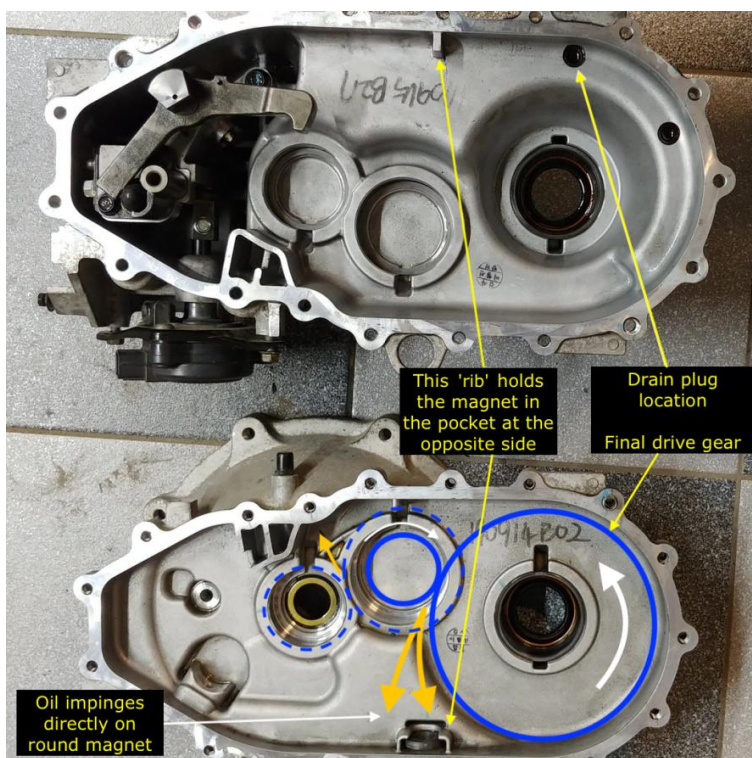
Photo: KiwiME, orig from ioniqforum.com

- iii) Common design practice would have the magnet placed inside the GRU where fresh particles would be most likely to find it quickly and be removed from circulation. Perhaps for ease of installation the magnet has been designed to sit loosely in a pocket on the GRU floor and kept from escaping by a rib feature opposite. As such it can move approx 4mm out of the pocket until it hits the rib. It can also move about 2mm side to side and about 3mm upwards.

Note that the magnet in my Kona at 27,000 km (see photo above) appears free of the particles it was designed to catch. Now why would that be? This evidence is essentially the smoking gun.

For whatever reasons particles are either not being caught, or are caught then worn down and eventually rubbed off during movement of the magnet. Simple tests demonstrated that the magnet does have good, if not excellent magnetic attraction.
